OTTAWA BIKE AUDIT REPORT

11.12.24

CONTEXT & PURPOSE

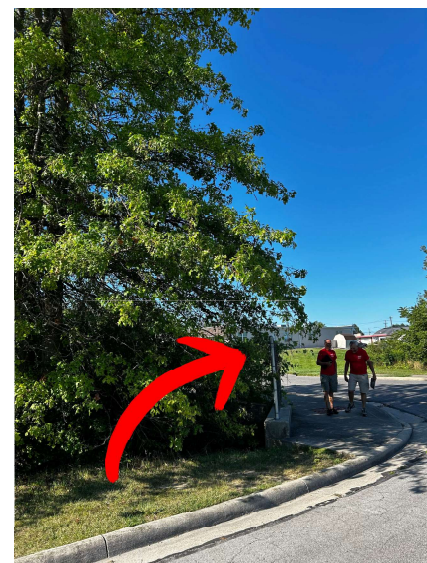
1. Issue: Blind spot
Recommendation: Routine trimming of vegetation & litter pickup. Also recommend adding stop sign to incoming traffic side to decrease speed and help with blind spot.

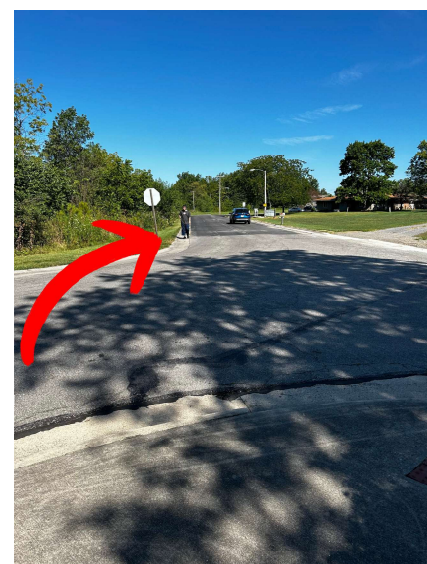
2. Issue: No sidewalk or crosswalk. Residents walking on road with potential for incoming traffic not to see right away.
Recommendation: Add sidewalk to North side, along with crosswalks at each side of intersection.

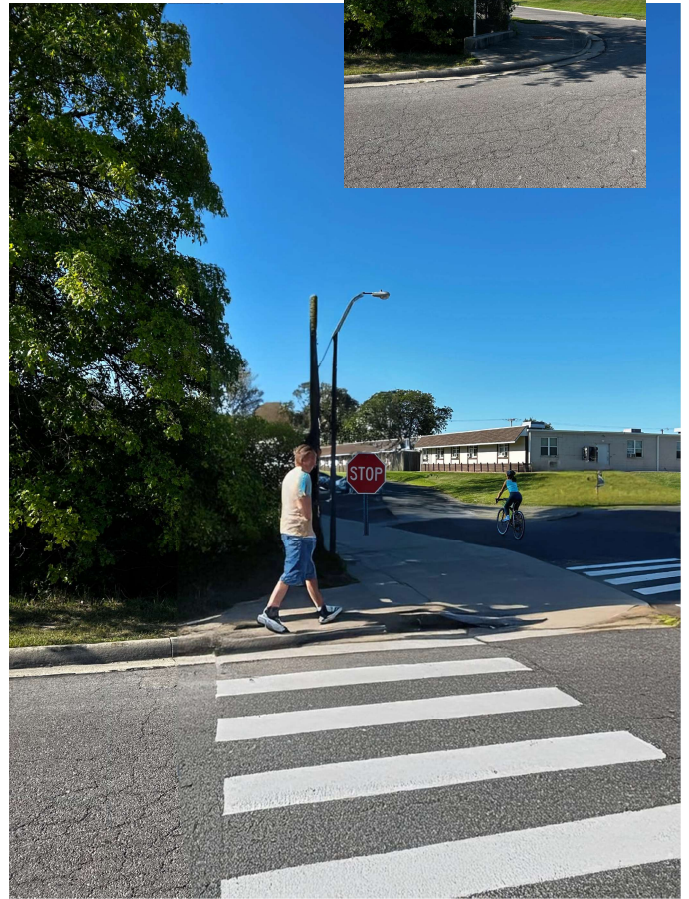
SELHORST DRIVE

Selhorst Drive was the only location from our audits where adults were observed cycling. Cyclists road on the street at this location as well, leading us to focus our improvements on the roadway. In our kick-off meeting, residents noted that this was a well-traveled bike pathway from residents in the neaby subdivision. We also heard about a Tawa Manor resident that had been struck by a vehicle at this intersection. Our audit found 3 interventions that could be accomplished in the short-term that could improve safety at this location. These include improving the visibility around the corners and reducing incoming vehicular speed. Looking at the future of this intersection, additional sidewalks and crosswalks will help pedestrian safety. A few minor sidewalk hazards were noted, but since most cyclists were on the road - these have lower priority (although they are still tripping hazards for pedestrians).

Observation	Suggested Improvement	Short, Medium, or Long Term
Blind Spot at Cedarbrook Dr stop sign; Interviewed residents noted high anxiety here	Routine trimming of vegetation & litter pickup	S
No sidewalk on North side of Selhorst Dr; Residents walking on road with and against traffic flow	Add sidewalk with crosswalk	L
Speed limit not followed for incoming traffic from 224	Add stop sign coming in from 224 - making it a 3-way stop	S
Truck often parked close to intersection on Cedarbrook decreasing visibility	Add red curbing for no parking distance from stop sign	S
No strong connection to riding into town	Make sidewalks wider & make sure snow is not piled in pathway from Bowling Alley	L & S
No crosswalks at any side of intersection of Cedarbrook and Selhorst	Add crosswalks to each side	M
Accessibility pavers are sinking causing hazard	Reset	M
Potential hazard at stormwater inlet if tire goes off sidewalk	Fill in the gap	M

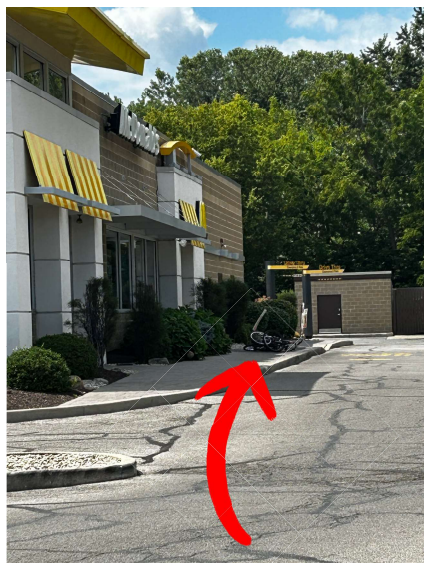
3. Issue: No bike parking at retail establishments
Recommendation: Promote a bicycle friendly business campaign to encourage retailers to provide bike parking

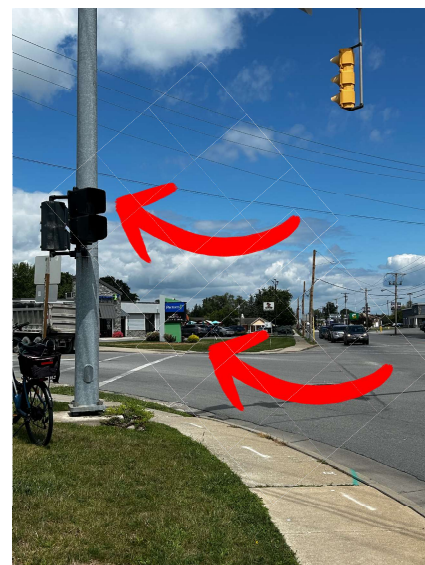
1. Issue: Crossing signals:
Missing on Partner's First
side and not working on
McDonald's side

Recommendation: Add to Partner's First side and fix light on McDonald's side

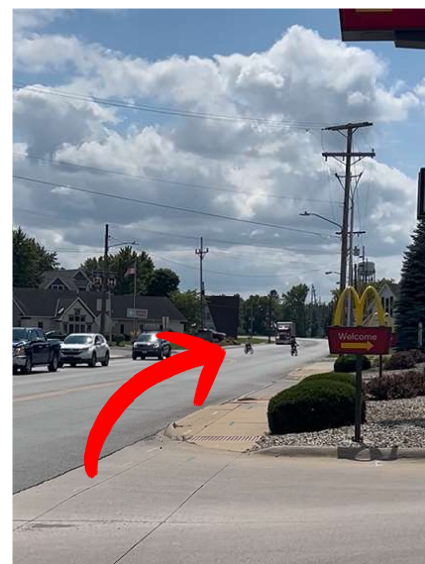
2. Issue: Multiple cyclists observed crossing 65 from 8th Street. This is also where most vehicles are completing their right turn.
Recommendation: Could this be a signalized crossing?

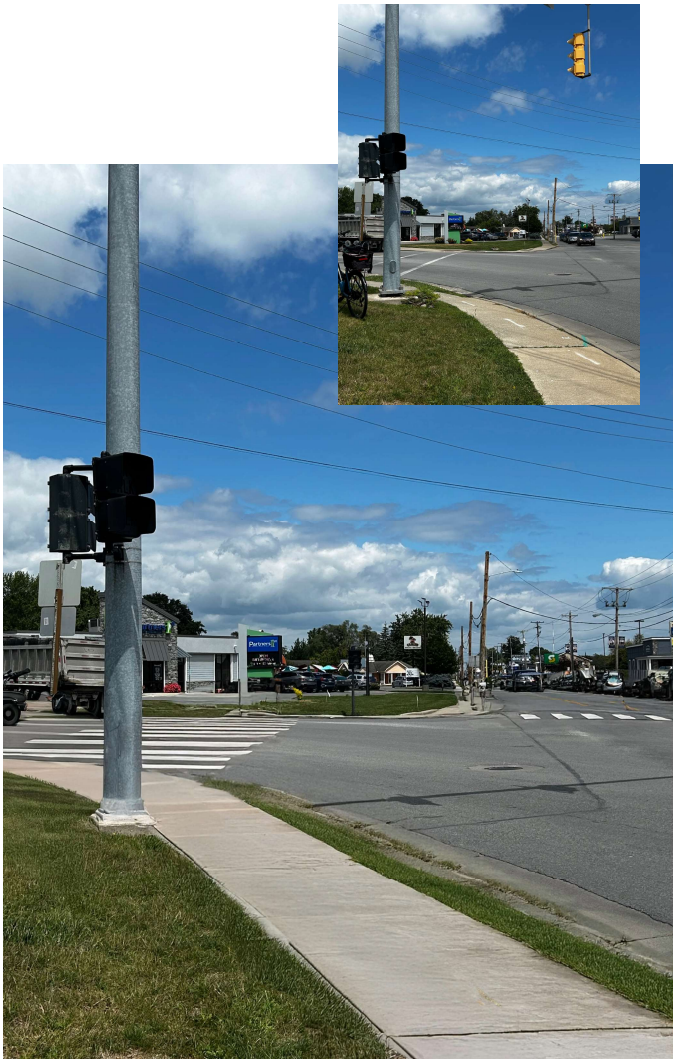
MCDONALD'S INTERSECTION

The McDonald's intersection was discussed during our kick-off meeting because of the anxiety cyclists experience at this intersection. It was also noted that a resident from Tawa Manor routinely rides through this area with her three-wheel trike and her tires get stuck at the edge of the sidewalk. Most of the cyclists observed were going to either McDonald's or Marathon for snacks. We did not observe any crossing at any of the crosswalks: they either stayed on the sidewalk or crossed at a location further from the intersection. In the short to medium-term, we can improve the crosswalks with heightened visibility and fixed crossing signals. If a bike lane is not feasible, we recommend widening the sidewalks and adding more buffer between sidewalk and road, especially at the corner of McDonald's.

Observation	Suggested Improvement	Short, Medium, or Long Term
Sidewalks are tight, with short area at corner that has no buffer between sidewalk and road. No bike lanes so sidewalk is more common path.	Add bike lane or wider sidewalks (some sidewalk repairs needed). If sidewalks, make sure there is a barrier along entire path.	L
No crossing signal at Partners First side of intersection & crossing signal on McDonald's side of Partners First is not working.	Add crossing signal back (looks like there used to be one) and fix crossing signal light. (countdown/audible kind would be ideal)	M to fix existing, L to move towards countdown/audible
Left turn signal time on Defiance is uniform at all times of day despite much lower traffic flow in off-peak times	Opportunity to reduce signal time based on time of day	L
Right turn at pedestrian island is not used - they turn before gas station at 8th St. At 8th is also where cyclists were observed crossing 65 instead of at crosswalks.	Signalized crossing at 8th St	L

No signage alerting drivers to pedestrians/bicyclists	Add signage at key points of intersection	M
No bike parking at McDonald's. Common route end point. Bikes left on ground.	Promote a bicycle friendly business campaign to encourage retailers to provide bike parking	S

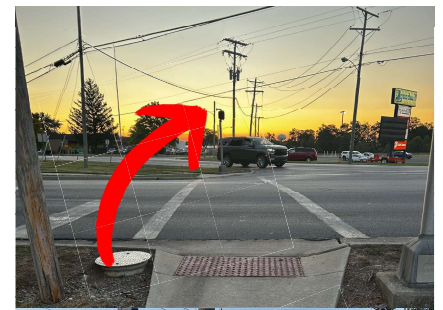
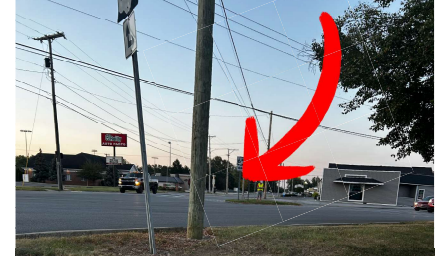
1. Issue: Crossing signals:
Missing at 109 side and not working at Locust/Revitalize side

Recommendation: Add to 109 side and fix light on Locust side. Also recommend adding crosswalk from pedestrian island to Revitalize. (This was noted in traffic study.)

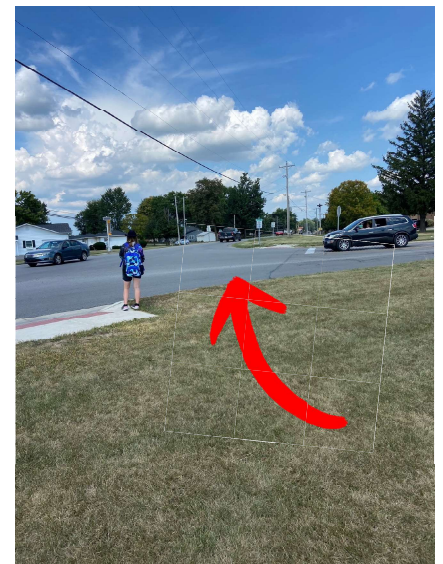
2. Issue: 11th St: No crosswalk & curb cut not in direction of travel; left-turn vehicles cannot see they are in school zone
Recommendation: Add crosswalk and add school zone signage facing 11th St

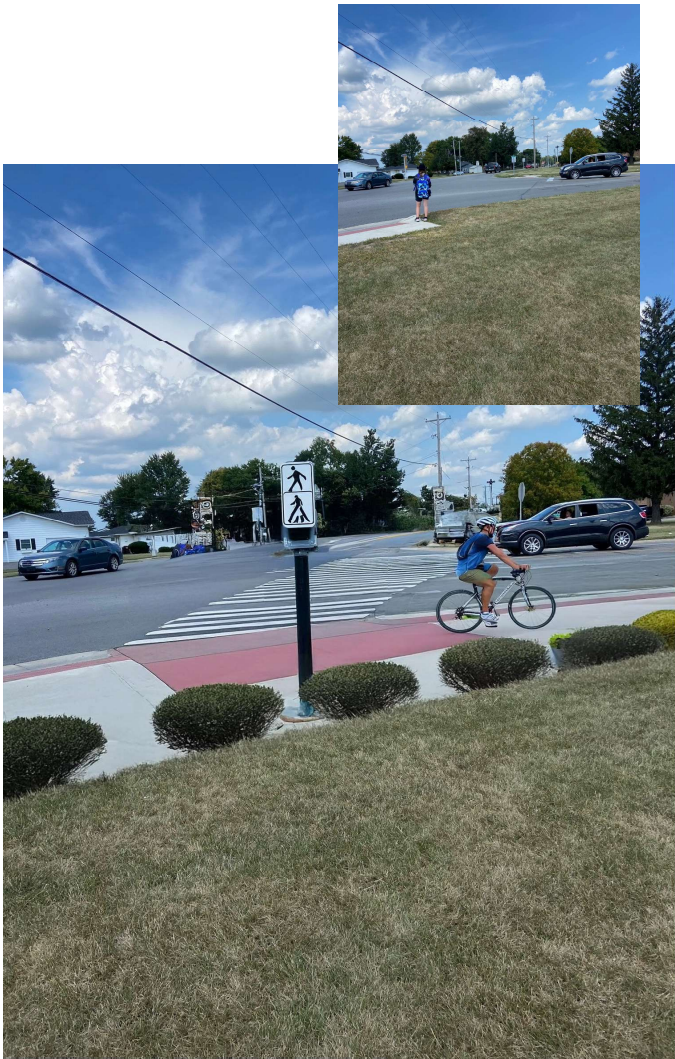
HIGH SCHOOL INTERSECTION

The high school intersection was chosen because of its proximity to proposed future bike pathway connecting our schools and because of the anxiety cyclists feel at it. Most observed cyclists were en route to an elementary school. Several pedestrians were observed en route to the high school. 11th Street was felt to be the highest hazard. One pedestrian waited 5 minutes before being able to cross traffic. There was also a near collision observed. We would strongly encourage adding a crosswalk with a signal at this location for both cyclists and pedestrians. This could be coupled in the long-term with a wide path towards the park for the future bike trail. There are also opportunities for crosswalk & signal at the pedestrian island. One of the existing crossing signals did not work, while another appeared to be removed and needs replaced.

Observation	Suggested Improvement	Short, Medium, or Long Term
No crosswalk across 11th street and curb cut not angled to street. Also observed two cars turning onto 11th nearly collided.	Add crosswalk	M
Crosswalk across 65 to parking lot is a long time in traffic	Move to right angle across - less time needed for crossing; this is also recommended in traffic study	M
School zone: was not followed by 65'ers and not seen by those coming from 11th St	Add signage facing 11th St.	S
No signage alerting drivers to pedestrians/bicyclists	Add signage in key areas.	M
Crossing signal crossing 109 is missing and crossing signal crossing Locust was not working	Add crossing signal back (looks like there used to be one) and fix crossing signal light. (countdown/audible kind would be ideal)	M to fix existing, L to move towards countdown/audible
Pedestrians crossed Locust behind traffic and not at crosswalk	Make existing crosswalk artistic to encourage use and draw attention to it.	M

No crosswalk from pedestrian island to Revitalize	Add crosswalk; this is also recommended in traffic study	L
Steps to get to high school & sidewalk sloped/uneven along 109	Add handrails and potential 'runnel' for steps. Ramp to sidewalk to replace stairs with sidewalk repairs.	S for handrails, L for ramp

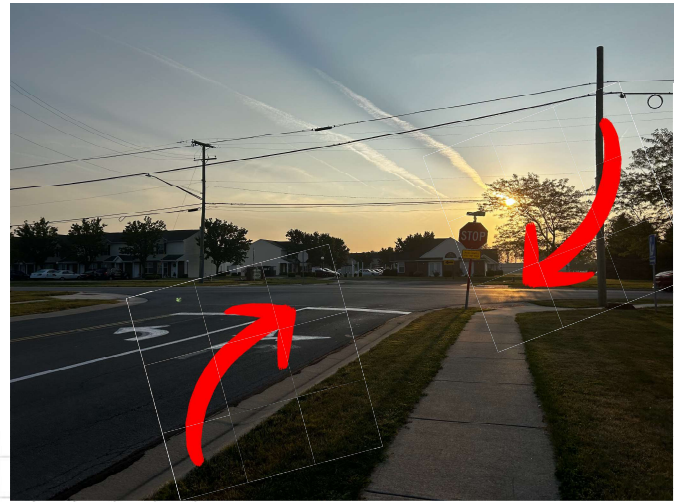
PUTNAM PARKWAY

1. Issue: No crosswalks across Putnam Parkway
Recommendation: Adding minimum crosswalk at 109, across 109 and near Library. (Also recommended in Traffic Study.)

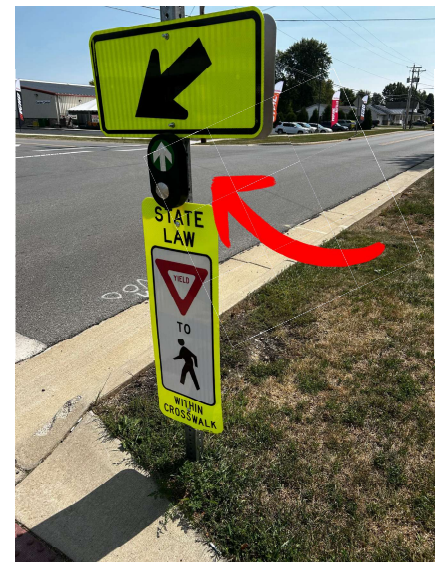
2. Issue: Crossing signal does not work at different times of day; Most observed pedestrians did not use button; Vehicles did not yield
Recommendation: Check power system to ensure lights work on peak times; Education for pedestrians

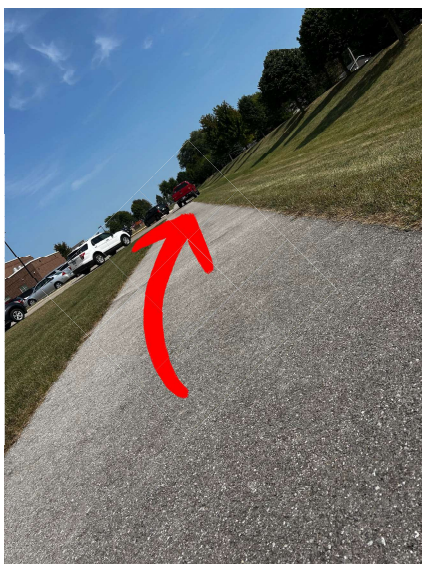
3. Issue: At drop-off/pick-up vehicles block path; multiple lights broken on path; no access to drinking water or trash receptacles
Recommendation: Shift drop-off/pick-up lane; fix broken lights and add amenities such as water fountain, trash cans and benches along path

Walking path is blocked by vehicles during drop off and pick up	Shift lane for drop off and pick up	M

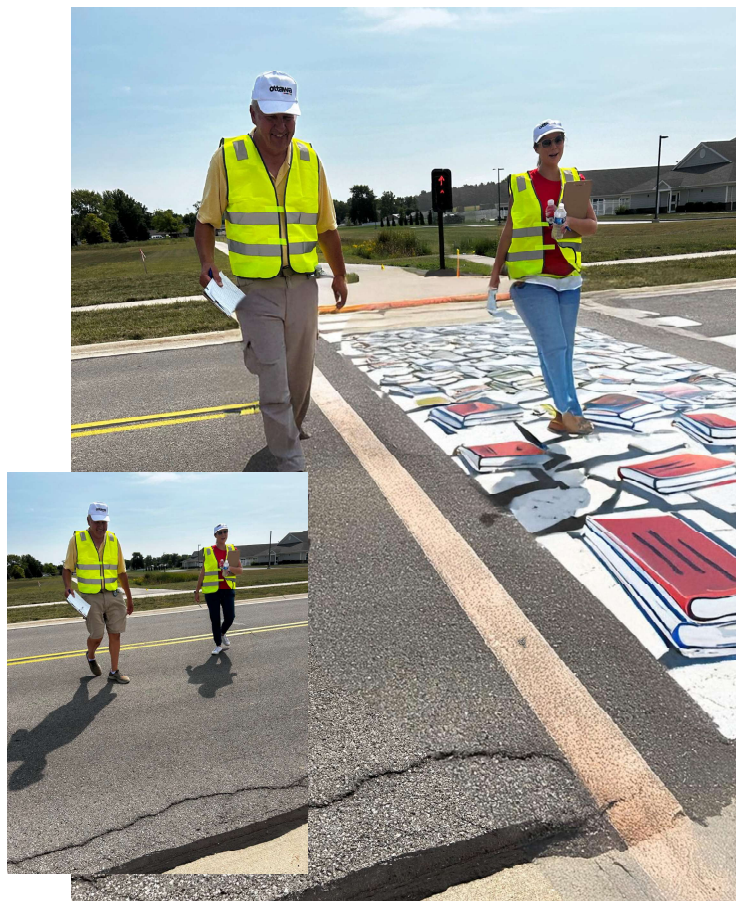
PUTNAM PARKWAY

Putnam Parkway was selected as an audit location because of its proximity to the proposed bike route, along with the number of services for seniors and children provided on the road. The largest observation of note was that over two audit time periods, zero cyclists were observed. We had expected at least a few riders going to the elementary school or the YMCA but did not have any. Putnam Parkway being spliced between two heavy trafficked roads creates a large barrier for cyclists. There is a signalized crossing at the Glen Meadows intersections for pedestrians, however, many do not use the button and many vehicles do not stop for the pedestrians. It was also noted that the lights did not come on at multiple hours of the day. There were several pedestrians observed, but most crossed at 109/Putnam Parkway without crosswalks.

Observation	Suggested Improvement	Short, Medium, or Long Term
No crosswalks across Putnam Parkway and no crosswalk across 109 at housing complex.	Add crosswalks at 109 & Putnam Parkway, as well as at least one somewhere near the Library. Consider artistic crosswalk at Library.	M
No signage alerting drivers to pedestrians/bicyclists	Add signage at key locations	S
Broken lights along walking path behind school	Fix lights	S
Crosswalk signal at Meadows Glen not working many times of day and not being used	Check power system to ensure lights work on peak times; Education plan for pedestrians	S
No sidewalk after the Meadows or Library so no connection to Rte 15	Add sidewalk	L
No drinking fountain or trash receptacles along walking path and opportunity for more seating	Add at least 1 trash receptacle. Benches donated over time. Drinking station added in future.	Trash & Bench - S Drinking Station - L
Path ends abruptly for bicyclists when it comes back out to Putnam Parkway	Is there opportunity to connect to new development behind the Meadows?	L

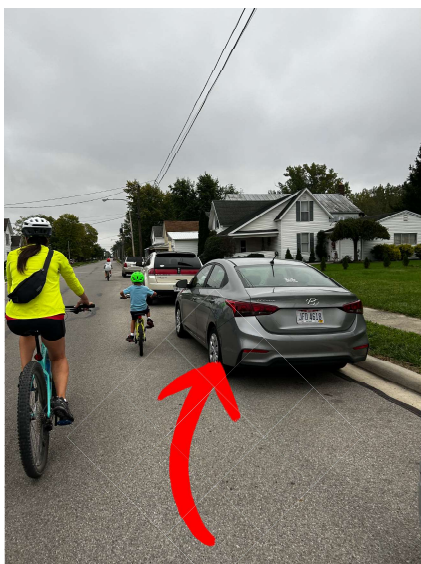
3. Issue: Potential obstructions throughout. West of tracks at Car-E-It, obstructions lie more on South side of road and East of tracks obstructions lie more on North Side of road. On road obstructions include parked cars. Off road include: utility poles, trees, mail boxes, driveways
Recommendation: Multimodal trail that starts on North side then switches to South before Fairgrounds

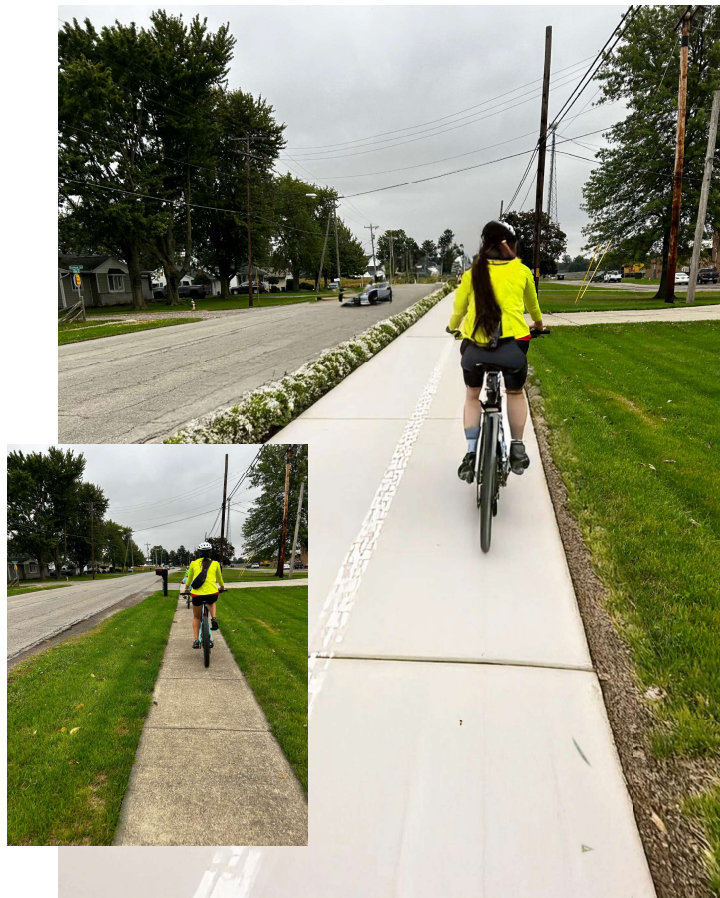
2ND STREET

As part of the Go Ottawa Challenge, we provided a survey to participants. The results were varied whether there should be a bike lane or a multimodal path, however, all agreed this pathway is a great potential trail for the area. There was a comment that the length would be pretty short for a bike trail. One idea that came from our bike audit was to use the Reservoir as a keyhole loop for the trail - giving cyclists two options: ride around the top and back or ride to the rear and park. Key areas of concern from both the audit and surveys were the 65 crossing, Car-E-It railroad tracks, and the Fairground intersection. If path were to be a bike lane on road, parked cars were a safety concern. If multimodal path, driveways are the larger concern.

Observation	Suggested Concepts for Trail
Crossing 65 will be issue. Oak & Thomas intersections also pose hazards.	Can we go under 65? Signalized crossing for Oak & Thomas.
Potential obstructions along path include: utility poles, trees, mailboxes, and driveways. West of Car-E-It tracks has less obstructions on North side of street. After the tracks, there seem to be less obstructions on South side of street.	Can we start on North and have a crossing at some point?
Fairgrounds intersection also potential hazard unless switch is made prior	Switch to south side of street for multimodal path before Fairgrounds to help with safety through that intersection
Current sidewalk is in need of repairs.	Utilize the need for these repairs to move forward with repaving of wider multimodal path.
Potholes at Reservoir cause a hazard for cyclists	Fill in & pave over. Could we pave all the way to rear of Reservoir?

No bike parking at either end of potential trail or access to drinking	Limited bike parking to be added at Arrowhead and Reservoir. Drinking water station to be added along path in long-term.
No public restrooms at Reservoir	Add seasonal port-a-let service similar to Arrowhead Park
